Manhole Inspection Summary

Manhole # S13G1_008MH

Insp Date: **3/7/08 1:36 PM**

Location Address: **3200 S Caton AV**

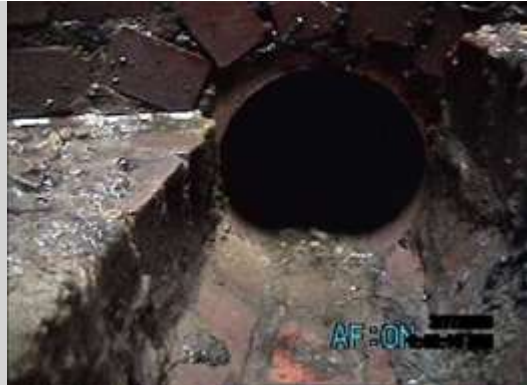
12 O'Clock Outflow

8 in. Circular Gravity Sewer
Pipe Out @ 12 O'Clock

Pipe Height: **8.4** (in.) Rod and Bar (Angled)
Pipe Material: **Clay** ☐ Pipe Lined
Invert Depth: **8.70** (ft.) Flow Characteristics: **Slow**
Deposits: ☒ None ☐ Mud ☐ Sludge ☐ Debris ☐ Grease
Silt Depth: **0** (in.) Deposits Extent:
Infiltration: **None** Pipe Seal Cond: **Sound**

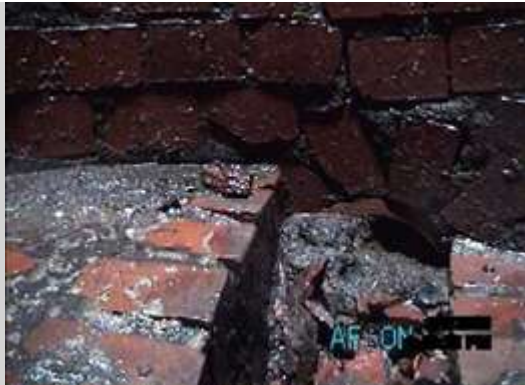
6 O'Clock Inflow

0.0 in. (w) x 6 in. (h) Unknown Gravity Sewer
Pipe In @ 6 O'Clock

Pipe Height: **3.6** (in.) Direct (Angled)

Infiltration: **None** Pipe Seal Cond: **Unknown**
